Ventilation and COVID-19 transmission risks on board of Dutch governmental ships

Atze Boerstra ^{a,b}, & Mark Verlinde ^a

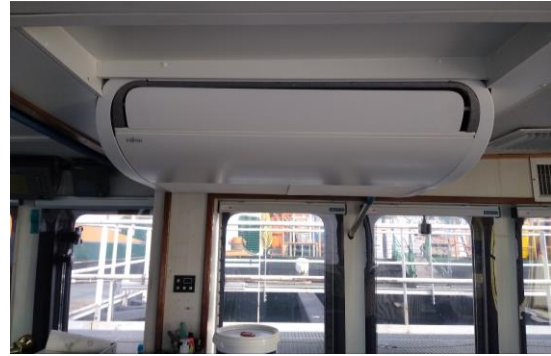
As far as decentral recirculation (at room level) is concerned: this was quite common especially in wheel houses, both in the larger and the smaller ships. Often decentral recirculation was part of an separate cooling system (split unit) that could be operated independent of the ventilation system (Fig. 2). Such decentral recirculation are seen as less of a problem than central recirculation [6]. That is, as long as 'other systems' (the basis ventilation systems) provide for adequate fresh air amounts independent of whether additional cooling systems are on or off (independent of outside whether).

Fig. 2 - Example of additional, separately operated, cooling system in wheel house of one of the smaller ships for day patrols (fan coil unit).

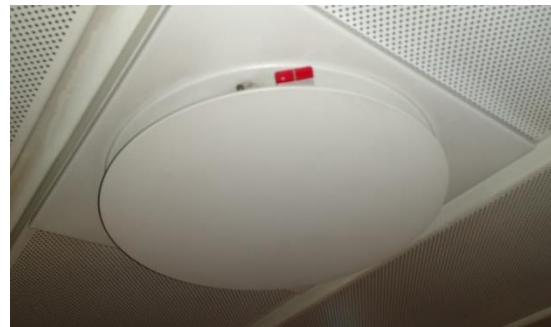
On board of most ships we found quite adequate options for end-users to control the mechanical air supply. For example, in many sleeping quarters of the larger ships, we found *adjustable* supply grills integrated in the ceiling (figure 3). This is positive as we know from several studies, that when people are provided with effective options to finetune fresh air supply and e.g. temperature that people are more satisfied with their indoor climate and less likely to develop certain health symptoms [11]. On the other hand, in many of the living spaces there was no option for additional natural ventilation (see also under 'operable windows').

Fig. 3 - Example of supply grill in the mess room of one of the larger ships; note the red handle that can be used to influence the amount of air supply.

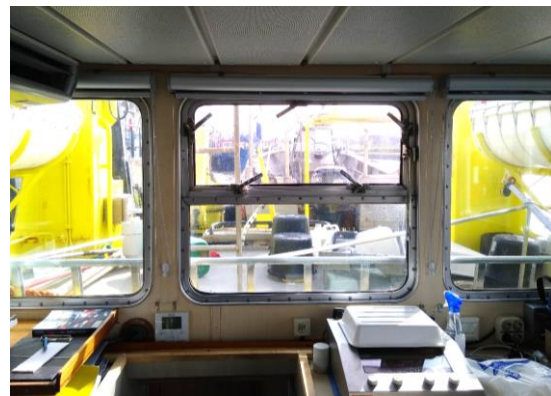
Most of the 16 ships were not equipped with operable port-holes or other types of operable windows. On the one hand this does not make sense as the ships involved, when on patrol, find themselves in excellent outside air (e.g. at sea). Nevertheless, operable parts in ships nowadays often are avoided due to insurance requirements and to avoid that ships take in too much spray- and rainwater during stormy, rainy weather. We found that the wheel houses, especially those of smaller ships, often did have operable windows (see figure 4) and/or doors with access to the deck. Some of these were well-designed (with devices that helped to keep windows and doors fixed in certain positions also with fluctuating winds), some lacked such devices.

Fig. 4 - Example of on-board operable window
