From Diesel to Electric to NZEB, an Energy Performance Contract in a Hotel

Abstract.

How could a 1975 4* 220# bedroom beach hotel evolve from an old system with Diesel Boiler and cooling only chiller to become a NZEB building. An Energy Performance Contract, funded by Innovation funds, an hotel in south Portugal obtained 60% Energy reduction, a new Chiller and integrated Heat Recoveries results on eliminating diesel consumption with almost free Sanitary Hot Water in the summer and next steps to achieve a NZEB Building. Energy Performance Certificate came from D to B which is already considered NZEB in Portugal.

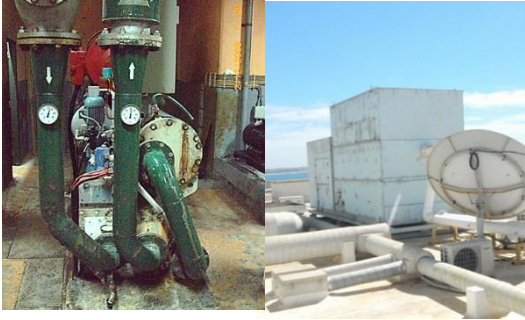
An original cold water/water chiller with cooling tower produces the hotel comfort cooling.

Existing Chiller had EER~1

Fig. 1- Old Chiller and Cooling Tower

Chiller circulating pumps were fixed speed. Fan-coils and AHUs had three-way valves with no hydraulic balancing.

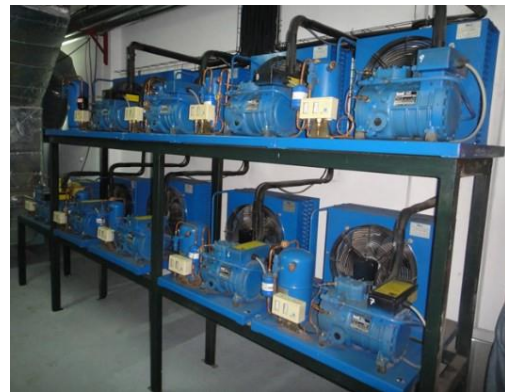
A big problem created in the 2005 remodulation were ten Condensing Refrigeration groups from the freezing and cooling modules located in a closed basement with minimal mechanical ventilation and an AHU-Air Handling Unit cooling the technical room in summer when chiller was on. That space overheated frequently creating breakdowns on the refrigerating machines

Fig. 2- Refrigerating Condensers

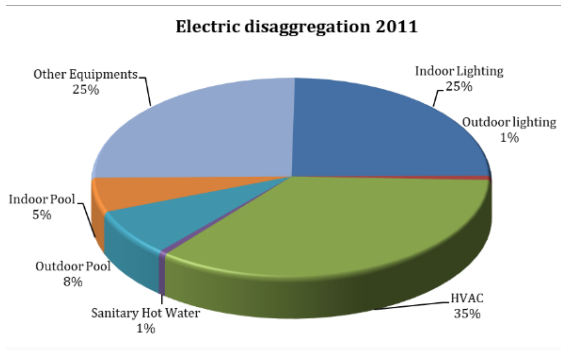
Fig. 4- Electric Consumption disaggregation

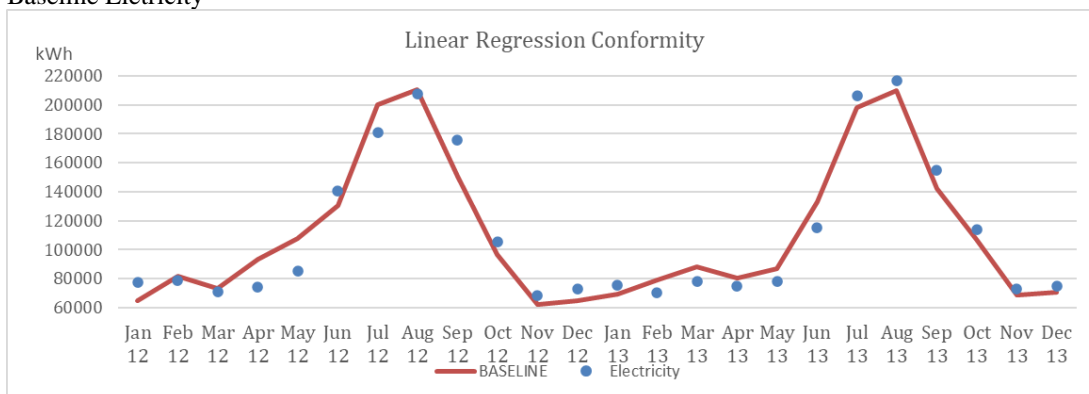
Fig. 6 – deviation between data and Electricity Baseline

$$E = a + b NC + c DDheating + d DDcooling$$

E= monthly Electricity kWh	DDheating = Heating monthly Degree Days in base 18°C
NC = Number of monthly clients	DDcooling = Cooling monthly Degree Days in base 24°C
a,b,c are constants	R ² = 94.4%

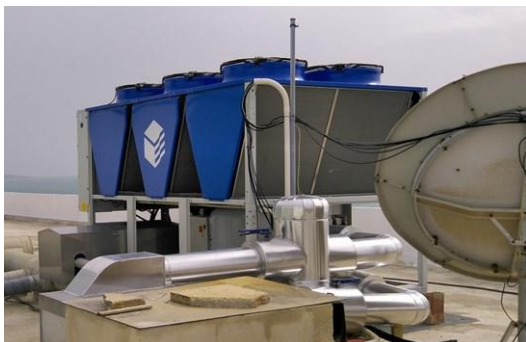
Fig. 8 – New Reversible 2 pipe Chiller 300 kW cooling

The great revolution consists of altering the Centralized Hydraulic schematics. We now have a chiller with Variable Speed in the Primary Circuit, Partial Heat Recovery at high

temperature using desuperheater with high Delta T on the heat recovery water. Heat production in counter current with the consumption of SHW and an auxiliary Heat Pump.

Installation of a Reversible Chiller produces all Cooling, Heating and most of the need for Sanitary Hot Water. We chose the one that had the best Values of EER and COP in Eurovent and in our study, but also the one that could achieve the desired Heat Recovery values.

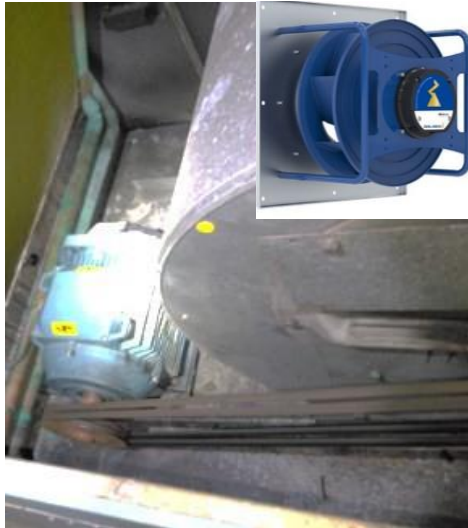
Indoor Pool Air Treatment Dehumidifier Ventilator was a centrifugal belt driven with 5.5 kW electric motor replaced by an EC plug fan of

2.2kW running at half speed at night time with 0.8kW power.

Fig. 12 – Old belt Ventilator and new EC Fan

Around 2k€ Investment for 1k€/year energy savings, two years Return on Investment, we still had four years to go, so was a easy decision.

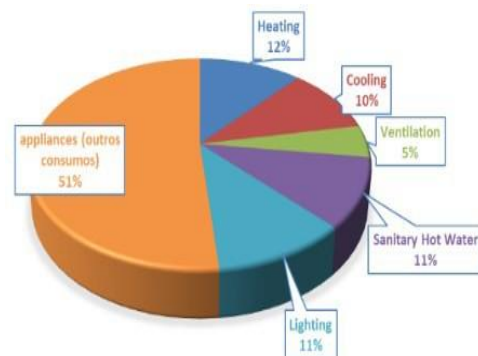
Fig. 14 Energy Disaggregation 2019

- Peak Electricity consumptions on summer due to high cooling needs remain, but are now at much lower level
- There is no Diesel utilization in summer and mid seasons, therefore all Sanitary Hot Water and Pool heating is being made with Chiller, Heat Recovery and Heat Pumps.

- Electrical consumption in Winter, from December to February, is almost the same as it was before, but with no Diesel spending, meaning other ECM-Energy Conservation Measures were able to reduce electricity use in Winter, like lighting, ventilation fans and better control on climatization by BMS

- Most Energy Consumption is about appliances, not traditional hvac, lighting and other regulated uses.

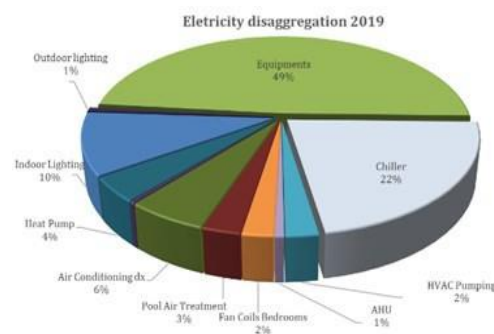
Fig. 15 Electricity Disaggregation 2019

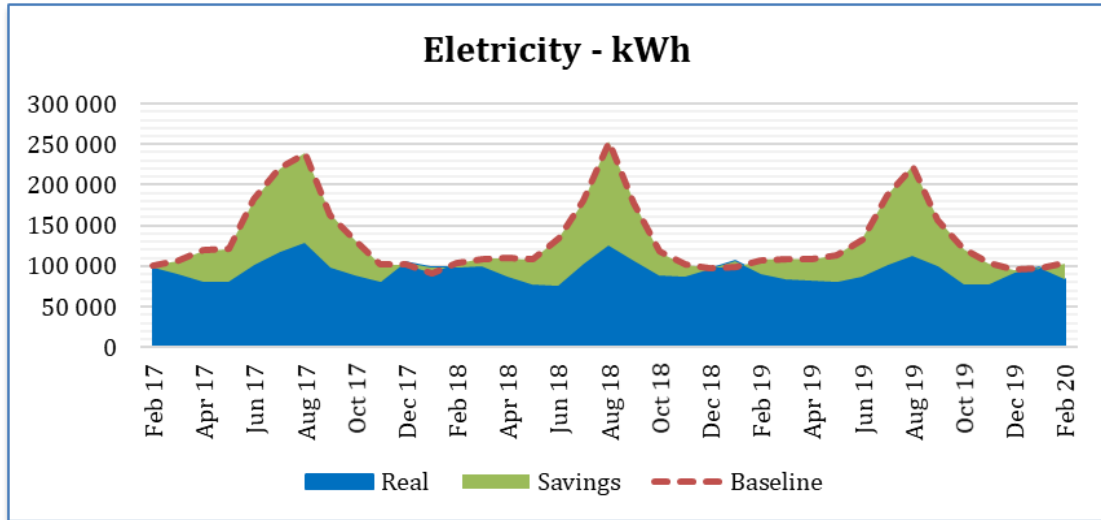
Fig. 16 – Electricity savings between Feb 2017 and Feb2020
